## FACILITY CONDITION ASSESSMENT

## WAUWATOSA CIVIC CENTER/LIBRARY/CITY HALL

Date of Report: July 1, 2015

On site Date: May 12, 2015

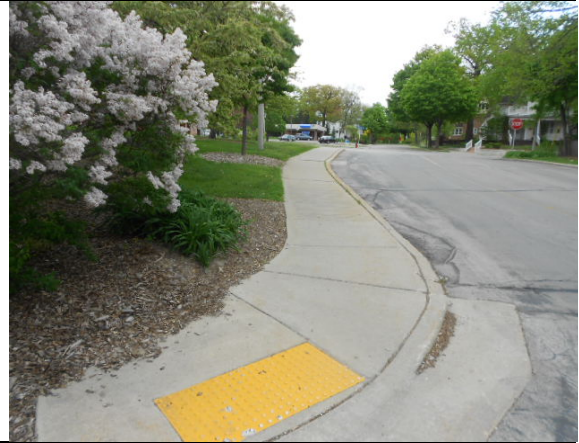
- The concrete sidewalks, curbs and gutters are in fair condition. Isolated areas of settlement, spalling and cracking of the concrete curbs and sidewalks are occurring throughout the site. The damaged areas of concrete curbs and sidewalks will require replacement early during the assessment period. The cost of this work is included in the Replacement Reserves Cost Estimate (Table 2).

Photo #10: Concrete sidewalk and curb cut

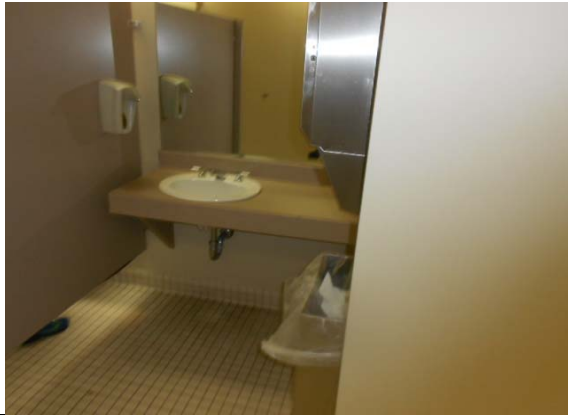
Photo #13:	Common area restroom – Missing pipe insulation below sink
------------	---

Report Section	ID	Cost Description	Quantity	Unit	Unit Cost	Subtotal	Deficiency Repair Estimate *
3.1	332388	ADA, Wrap drain pipes below accessible lavatory	2	EA	\$120.00	\$240	<b>\$240</b>
5.2	332478	Concrete curbs- replace	200	LF	\$7.00	\$1,400	<b>\$1,400</b>
5.2	332396	Remove and replace damaged concete paving	125	SF	\$8.00	\$1,000	<b>\$1,000</b>
5.4	332400	Retaining wall repair, concrete	25	SF Face	\$42.72	\$1,068	<b>\$1,068</b>
6.6	332530	Aluminum window replacement, 2-0 x 4-0, operable	121	Each	\$576.00	\$69,696	<b>\$69,696</b>
<b>Immediate Repairs Total</b>							<b>\$73,404</b>

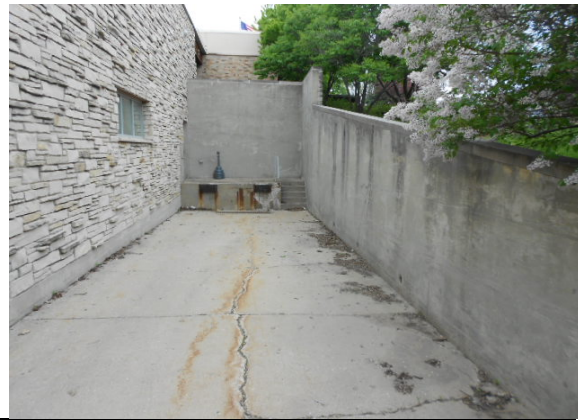
Photo #16:	Retaining wall at loading dock at Library
------------	---

5.4	332400	G2042 Retaining wall repair, concrete	0	0	0	25	SF Face	\$42.72	\$1,068	\$1,068																				\$1,068
6.3	332484	B3011F Asphalt shingles, removal and replacement of shingles	20	6	14	66	SQ	\$353.00	\$23,298														\$23,298							\$23,298

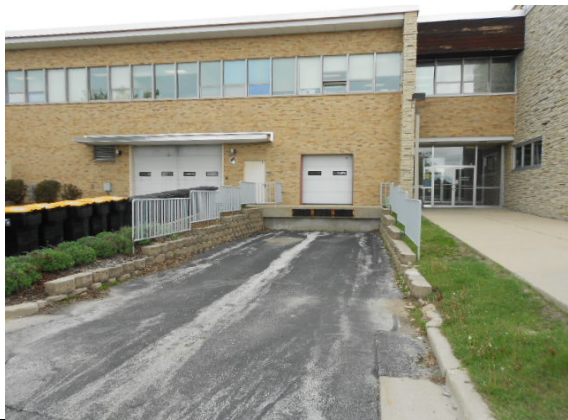
Photo #17:	Retaining wall at loading dock at City Hall
------------	---

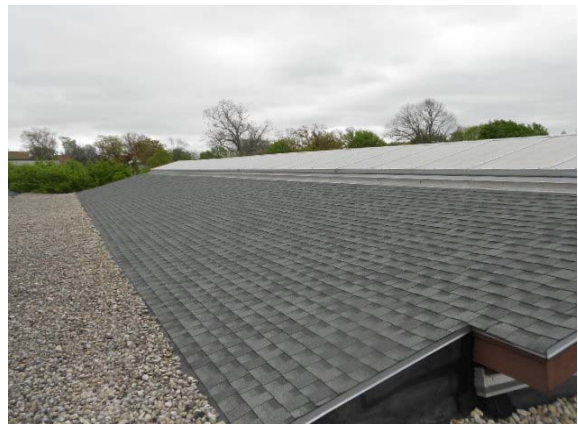
Photo #24: Asphalt shingle roofing

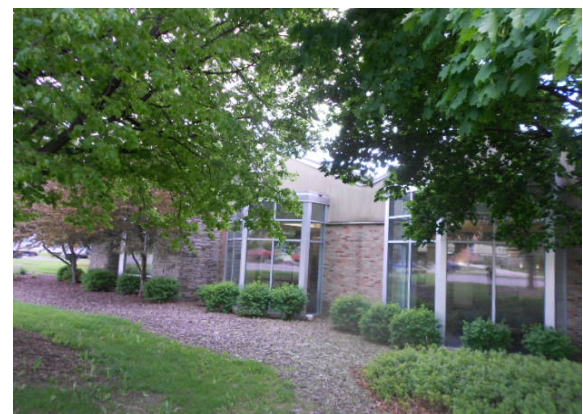
Photo #30: Exterior Insulation and Finish System (EIFS) North elevation (east end)

6.4	332486	B2011 EIFS refinish and crack repair, first floor	15	10	5	15	CSF	\$453.00	\$6,795						\$6,795															\$6,795
6.4	332496	B2011 Scrape and paint wood trim	10	6	4	750	SF	\$2.94	\$2,205					\$2,205									\$2,205							\$4,410
