## FACILITY CONDITION ASSESSMENT

## WAUWATOSA CIVIC CENTER/LIBRARY/CITY HALL

Date of Report: July 1, 2015

On site Date: May 12, 2015

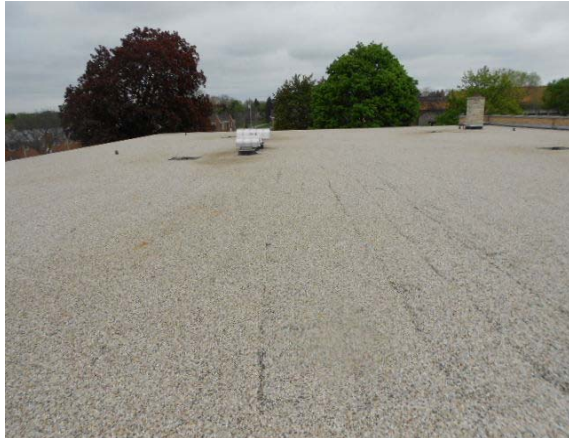
Photo #7: Roofing – modified bituminous membrane

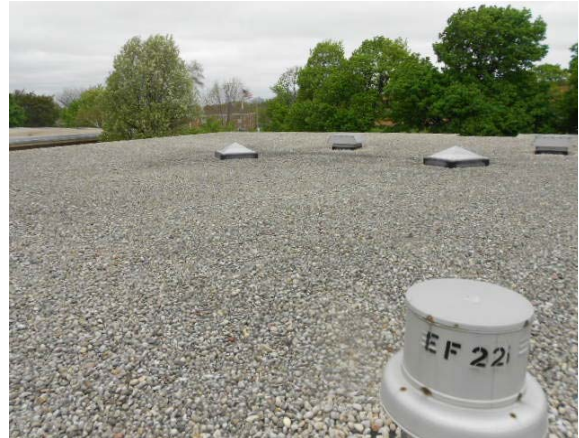
Photo #8: Roofing – EPDM membrane with stone ballast

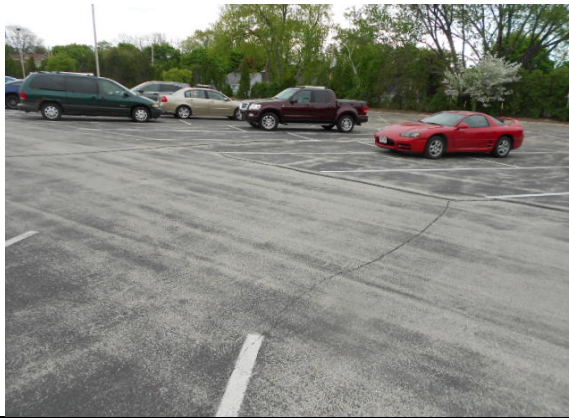
Photo #9: Asphalt pavement at parking lot

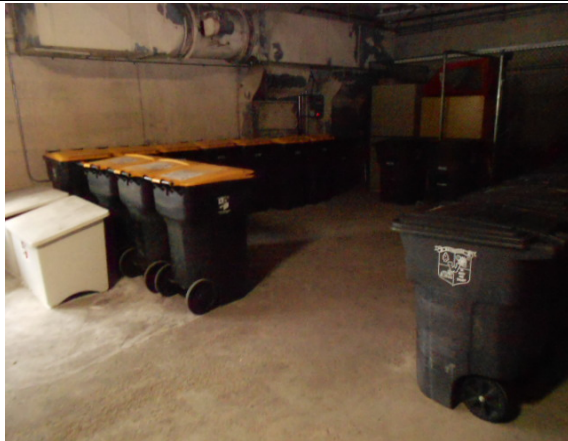
Photo #21: Trash and recycling containers

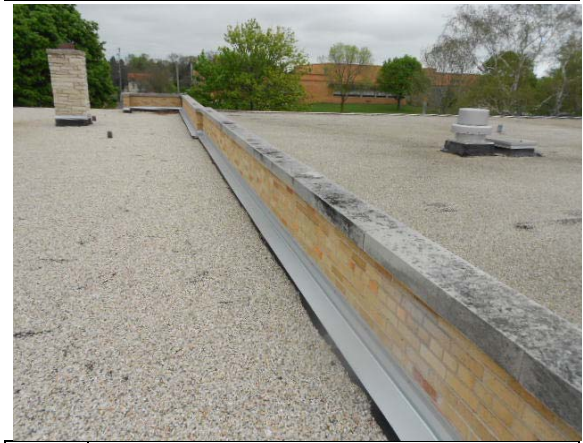
Photo #28: Parapet wall between City Hall and Civic Center

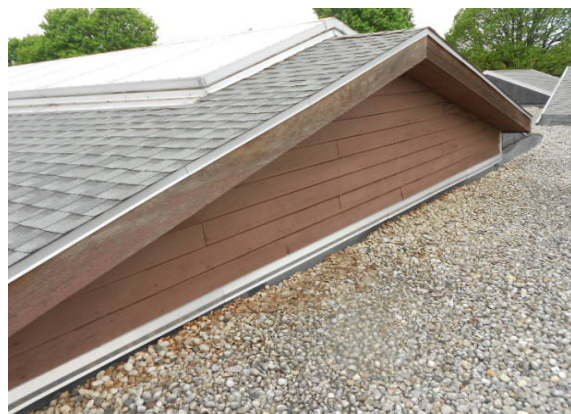
Photo #29: Wood siding and trim

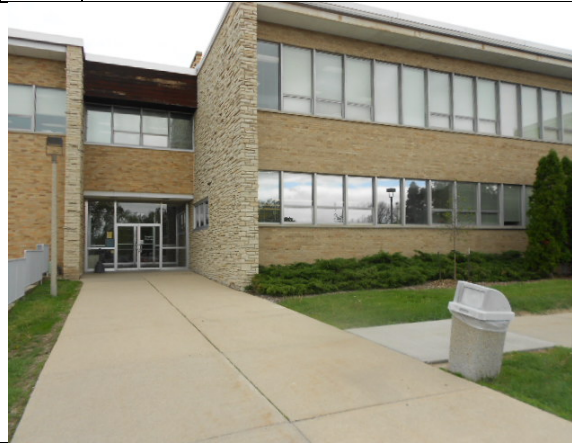
Photo #33: Windows and entrance doors

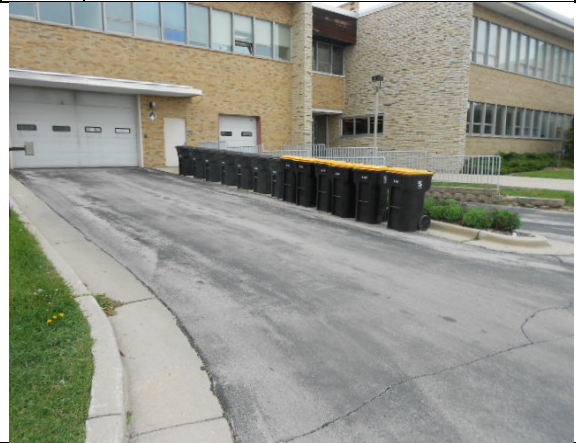
Photo #34: Overhead door to subterranean parking garage

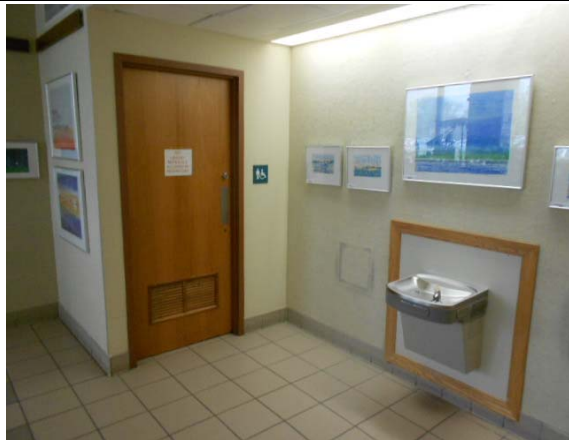
Photo #37: Drinking fountain

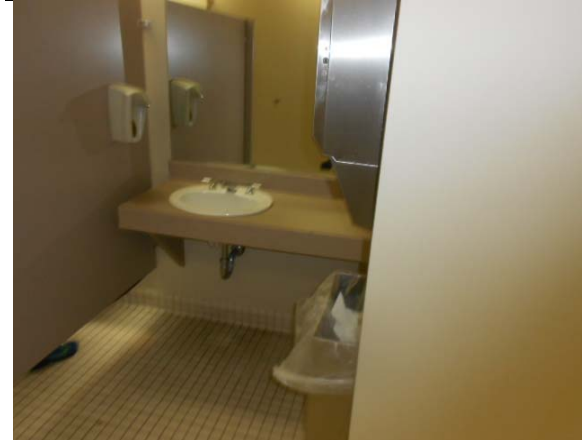
Photo #38: Common area restroom

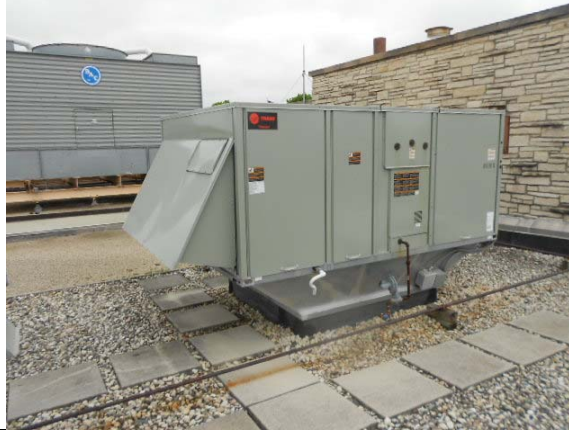
Photo #39: Rooftop HVAC package unit

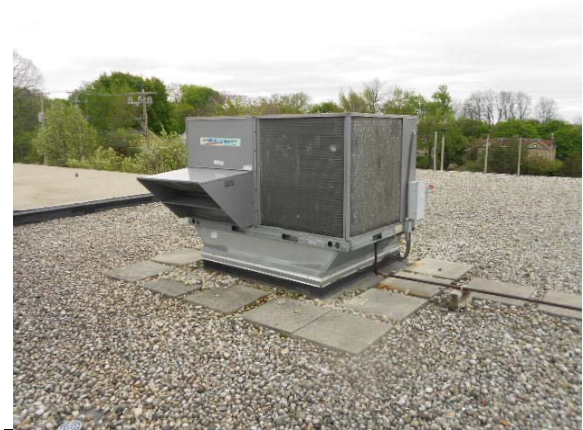
Photo #40: Rooftop HVAC package unit

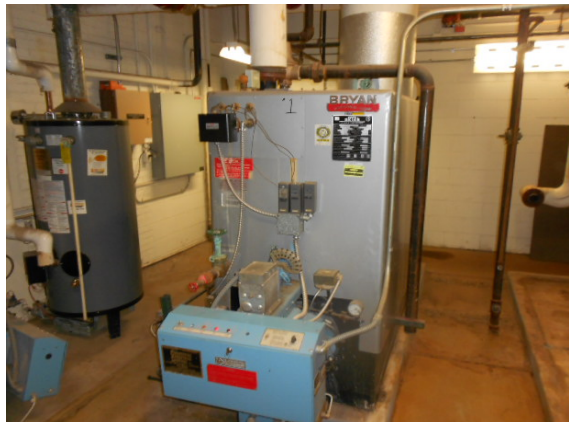
Photo #41: Heating boiler

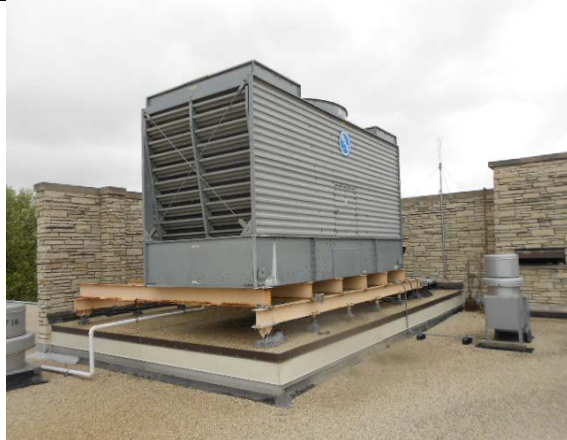
Photo #43: Cooling tower

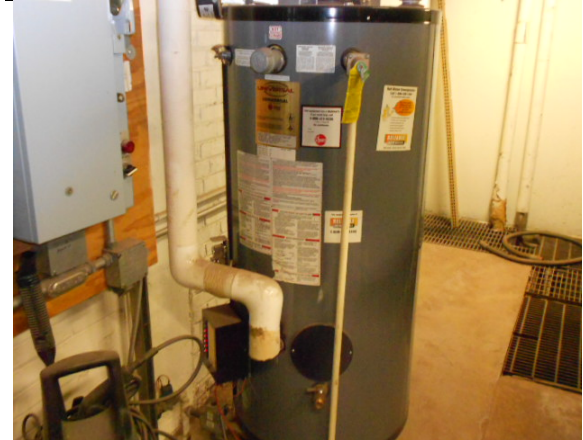
Photo #44: Domestic hot water heater (rented)

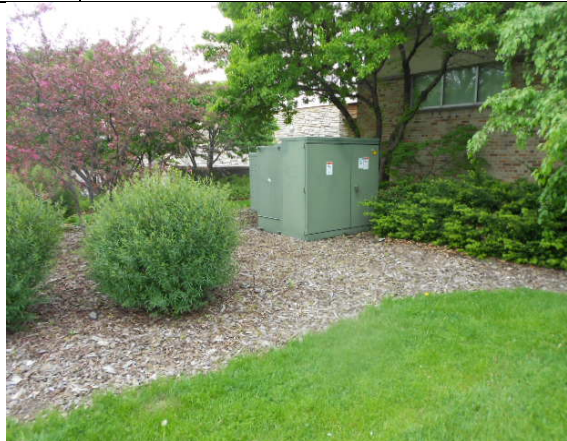
Photo #45: Pad mounted electrical transformer

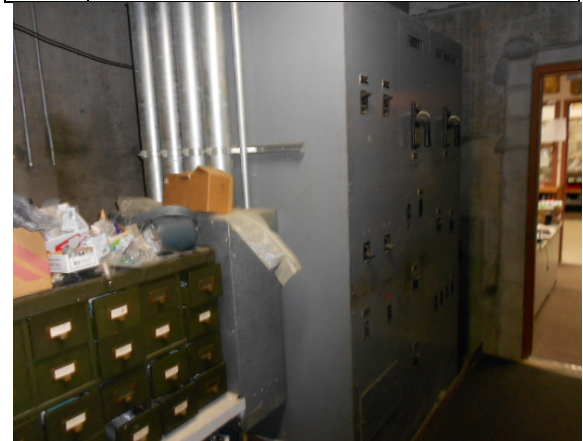
Photo #46: Main electric switchgear

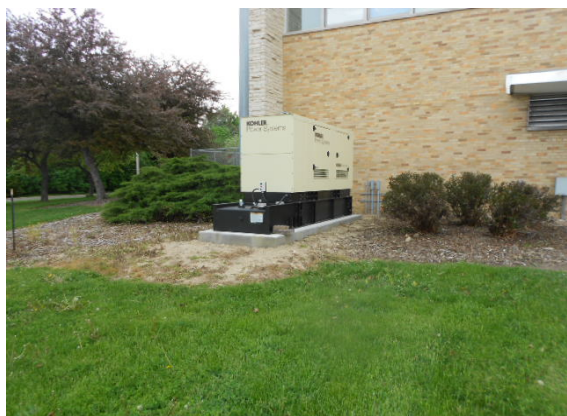
Photo #47: Emergency generator

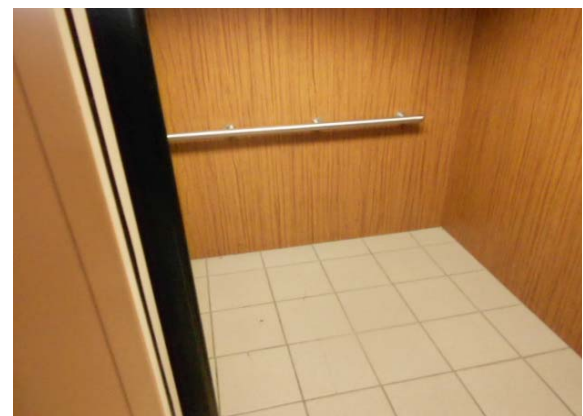
Photo #48: Elevator cab

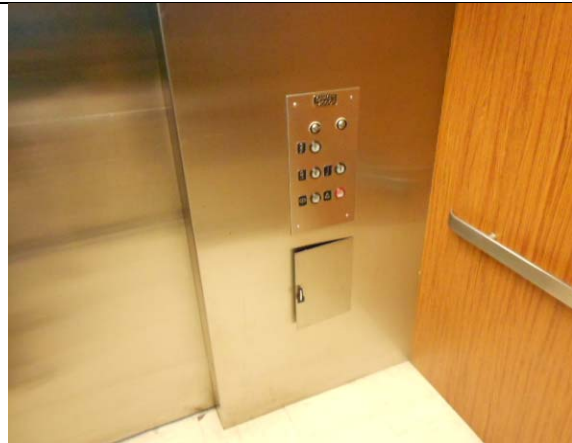
Photo #49: Elevator cab interior

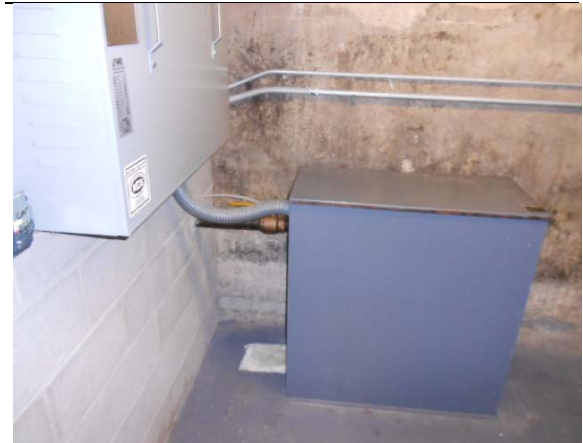
Photo #50: Elevator equipment

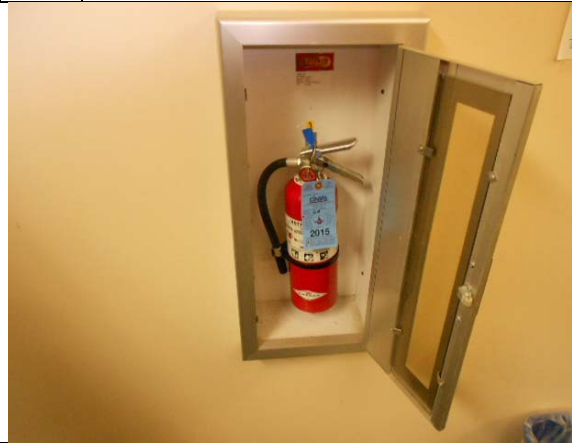
Photo #51: Fire extinguisher

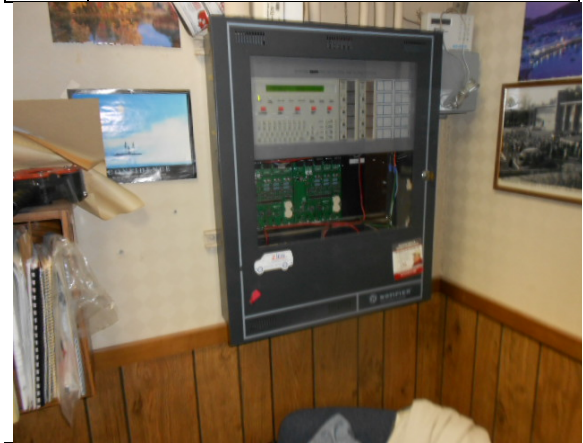
- The central alarm panel is six years old. Based on its estimated Remaining Useful Life (RUL), and because replacement parts and components for this type of equipment may be obsolete, the alarm panel will require replacement during the assessment period. The cost of this work is included in the Replacement Reserves Cost Estimate (Table 2).

Photo #52: Fire alarm control panel

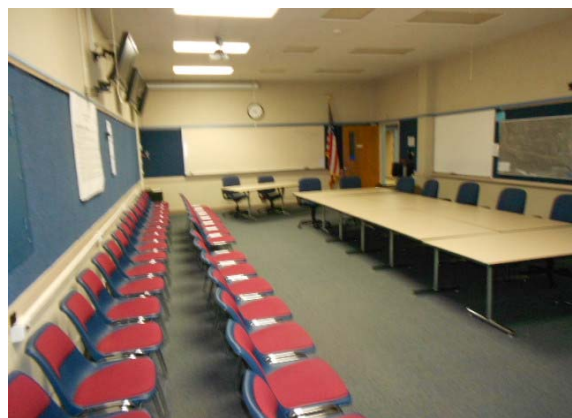
Photo #53: Interior finishes at City Hall

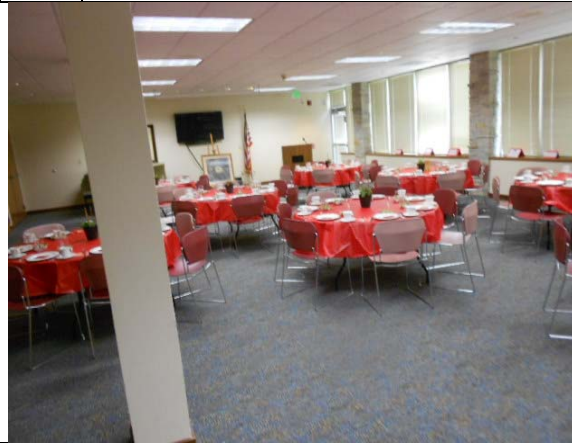
Photo #57: Interior finishes at Library

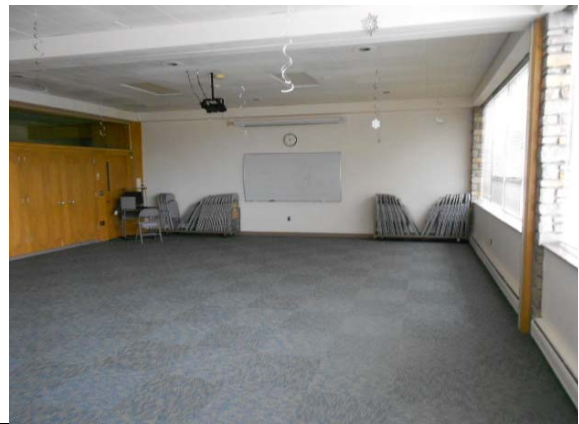
Photo #58: Interior finishes at City Hall

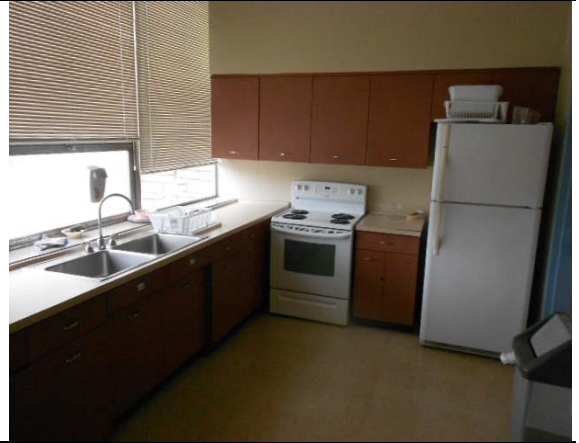
Photo #60: Kitchen at City Hall

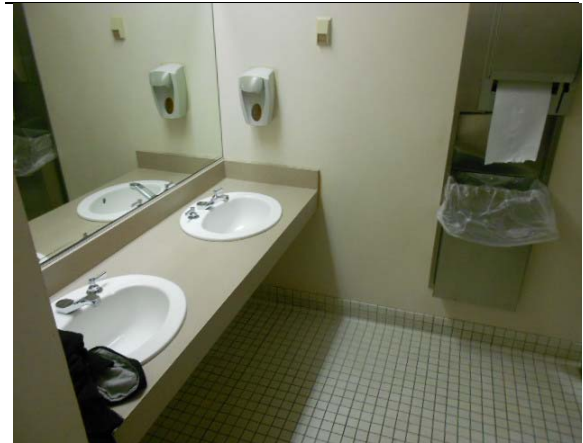
Photo #62: Tenant restroom

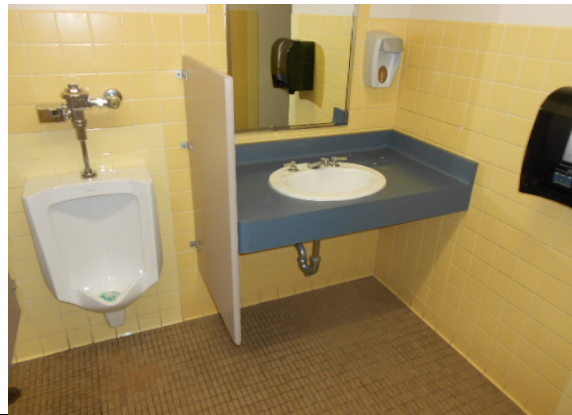
Photo #63: Tenant restroom

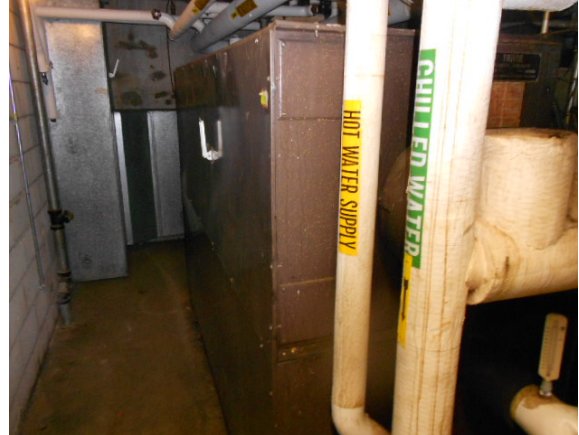
Photo #66: Air-handling unit

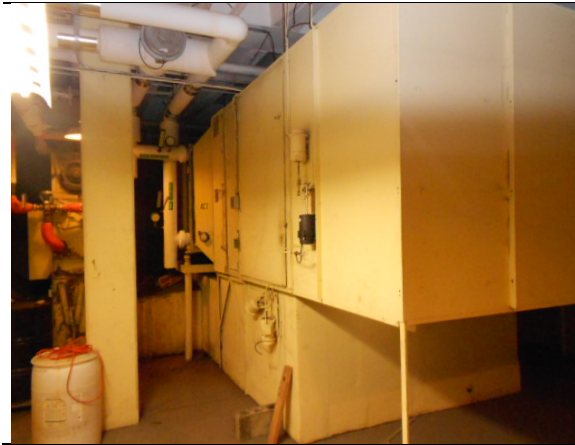
- The HVAC air-handling unit's equipment appears to be in good to fair condition. Based on its estimated Remaining Useful Life (RUL) and current condition, the air-handling units will require replacement during the assessment period. The cost of this work is included in the Replacement Reserves Cost Estimate (Table 2).
- The baseboard heaters appear to be in good condition and will require routine maintenance during the assessment period.

Photo #67:	Air-handling unit
------------	-------------------

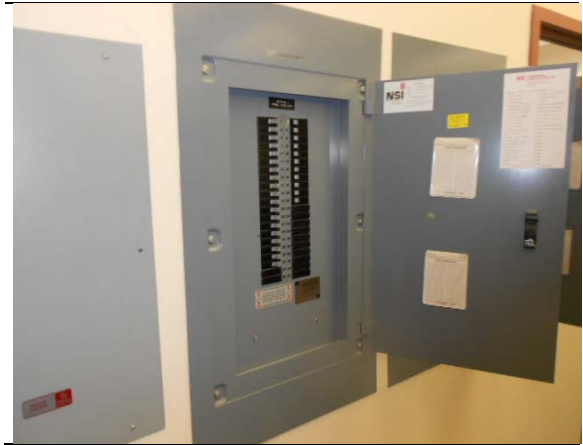
Photo #68:	Tenant unit – Electrical panel
------------	--------------------------------
