## FACILITY CONDITION ASSESSMENT

## WAUWATOSA CIVIC CENTER/LIBRARY/CITY HALL

Date of Report: July 1, 2015

On site Date: May 12, 2015

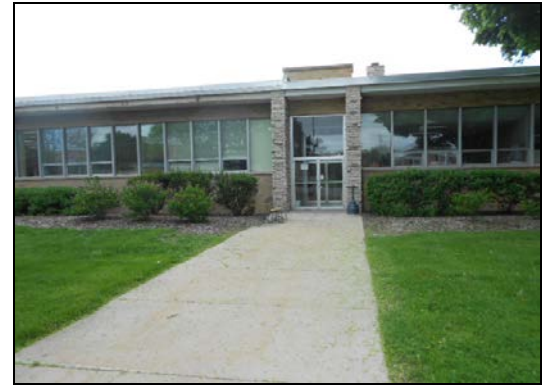
- The concrete sidewalks, curbs and gutters are in fair condition. Isolated areas of settlement, spalling and cracking of the concrete curbs and sidewalks are occurring throughout the site. The damaged areas of concrete curbs and sidewalks will require replacement early during the assessment period. The cost of this work is included in the Replacement Reserves Cost Estimate (Table 2).

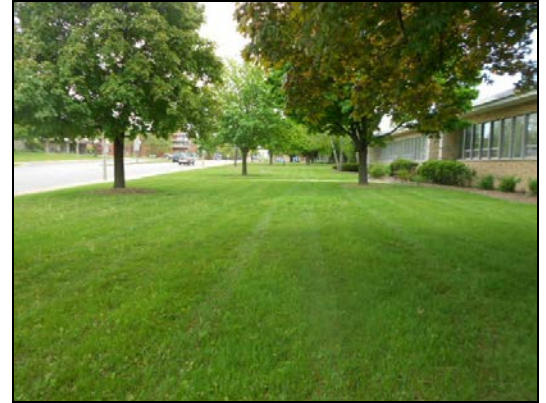
- The topography and adjacent uses do not appear to present conditions detrimental to the property.
- The landscape materials are in good condition and will require routine maintenance during the assessment period.
- The retaining walls appear to be in good to poor condition. The City Hall retaining wall is in good condition and will require routine maintenance during the assessment period. Cracking is occurring at the Library loading dock. The damaged portion of the retaining wall must be repaired within the year. The cost of this work is included in the Immediate and Short Term Repairs Cost Estimate (Table 1).

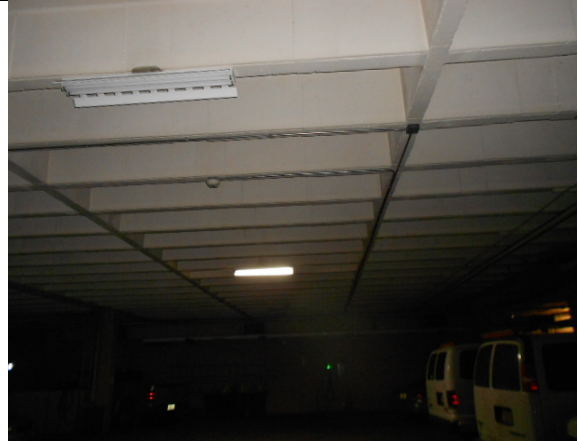
- The superstructure is exposed in some locations, which allows for limited observation. Walls and floors appear to be plumb, level, and stable. There are no significant signs of deflection or movement.

Photo #22: Superstructure

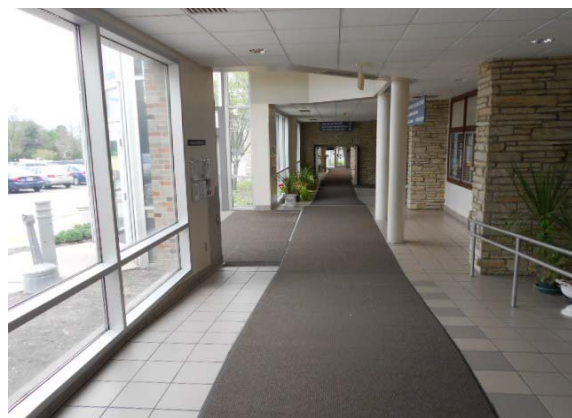
Photo #35: Lobby

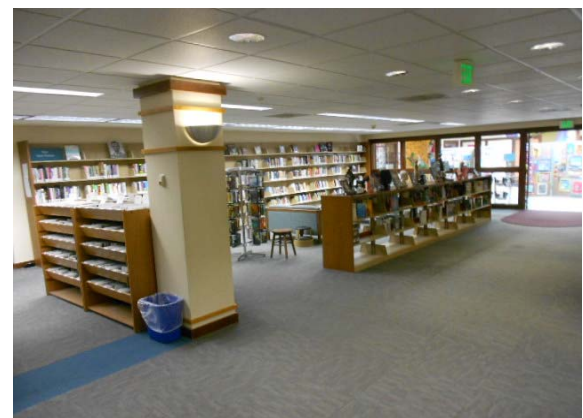
Photo #54: Interior finishes at Library Adult Section

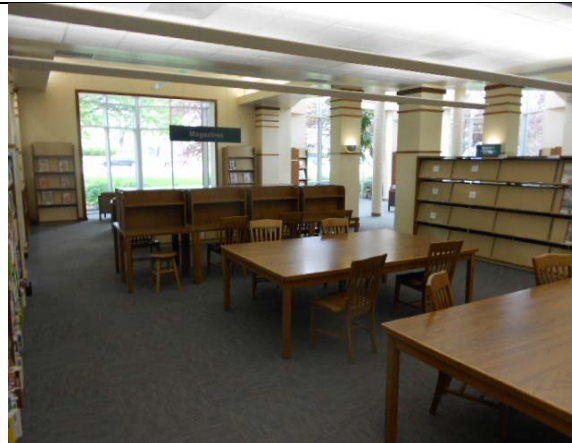
Photo #55: Interior finishes at Library Adult Section

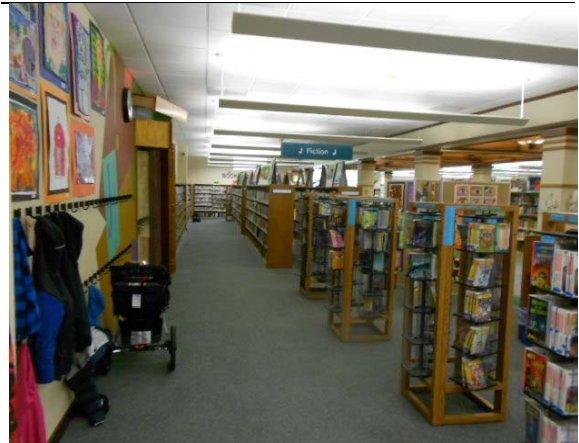
Photo #56: Interior finishes at Library Children's Section

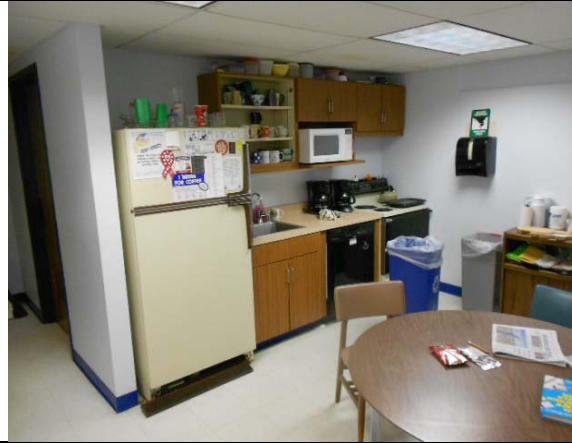
Photo #59: Kitchen at Library

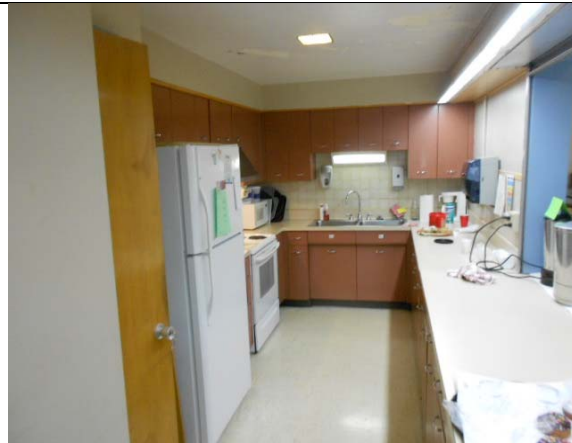
Photo #61: Kitchen at Civic Center

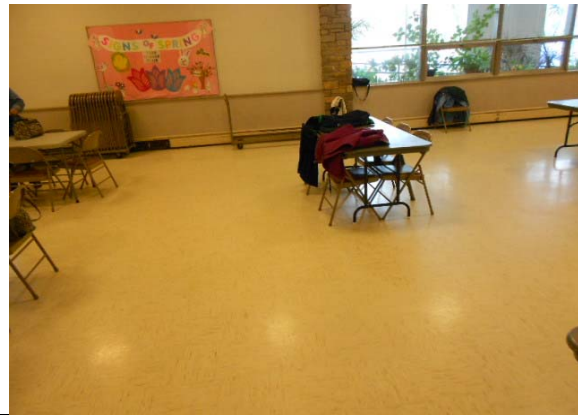
Photo #64: Auditorium at Civic Center

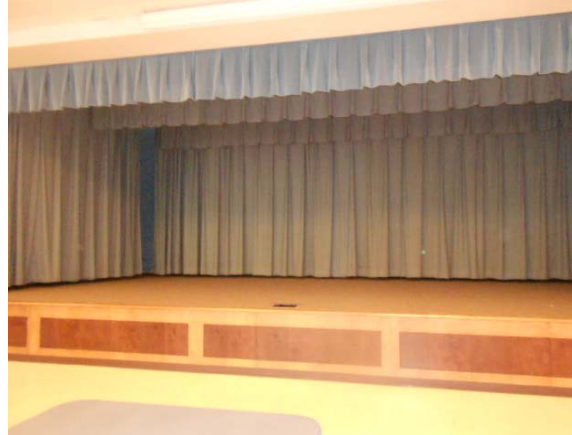
Photo #6525 : Auditorium/Stage at Civic Center
